# ***Robustness of timber structures in seismic areas***

Jorge M. Branco<sup>1</sup> and Luis A.C. Neves<sup>2</sup>

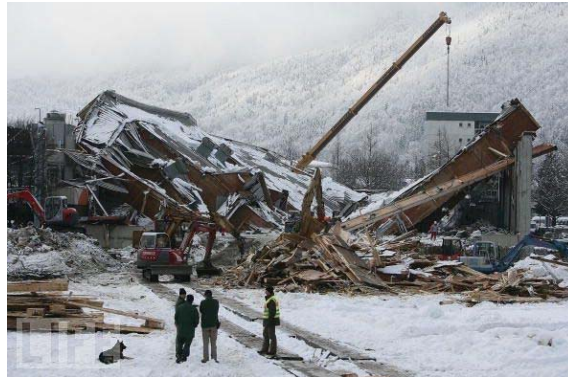
Figure 3 – Bad Reichenhall ice-arena collapse

At the beginning of the year 2006, 2<sup>nd</sup> January, the ice-arena roof in Bad Reichenhall collapsed under the actual snow load (Figure 3). Fifteen people died, thirty were partly or heavily injured. The main reasons for the collapse are: (i) use of urea-formaldehyde glue under moist conditions; (ii) mistakes in the static calculation; (iii) non robust construction; and, (iv) lack of maintenance. According to the findings of experts Winter and Kreuzinger [6], one of the three main box-girders on the east side failed first. Due to the stiff cross girders, the loads were shifted from the box-girder that failed first to the neighboring girders. These box-girders,

which were already pre-damaged were also overloaded due to which the entire roof collapse like a zipper. This transversal stiffness is, however, a desirable property under seismic design, and no real advantage could have been obtained from considering earthquake as a load. In fact, as shown in Figure 3 an increase in stiffness of transversal elements can, in fact, lead to an increased risk associated with damage.

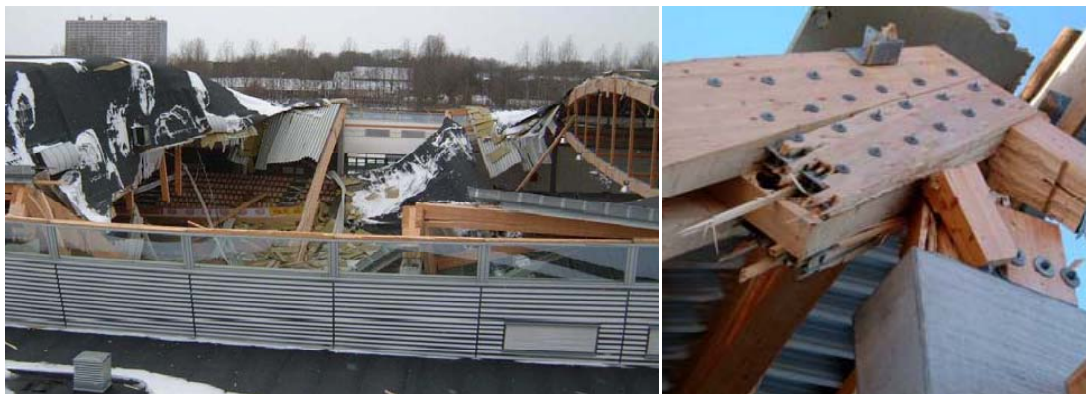
Figure 4 - Siemens Arena roof after the collapse of two trusses Munch-Andersen [7]

In the case of the Siemens Arena failure (Figure 4), the first consequence of a seismic design would have been the increase of transversal stiffness. This could have caused progressive failure, following the collapse of one truss, leading to large increase in indirect consequences of damage. In fact, the 12 m long purlins between the trusses were only moderately fastened, such that a failure of one truss should not initiate progressive collapse. As all trusses had much lower strength than required by the failure of a neighbor element, it might be fair to conclude that the extent of the collapse was not disproportionate to the cause, as analyzed by Munch-Andersen [7]. The result of a seismic design could have been an increase in transversal stiffness, which could have caused progressive collapse of the structure.

a) An intact truss is seen to the right

b) Rupture at the critical cross section in the corner connection

In these last two cases, the only possible advantage of seismic design would have been the closer attention paid to the detailing of connections, required for the definition of the

dissipation zones defined in EN 1998-1:2004. In fact, connections played a major role in both incidents, and a more careful design could have avoided the errors.
